Title: **Why Indeed Did the WTC Buildings Completely Collapse?**

Description: *Thirteen Reasons to Challenge Government-sponsored Reports and to Investigate the Controlled-demolition Hypothesis*

Author: Dr. Steven E. Jones, Journal of 9/11 Studies 5 September 2006/Volume 3

# Why Indeed Did the WTC Buildings Completely Collapse?

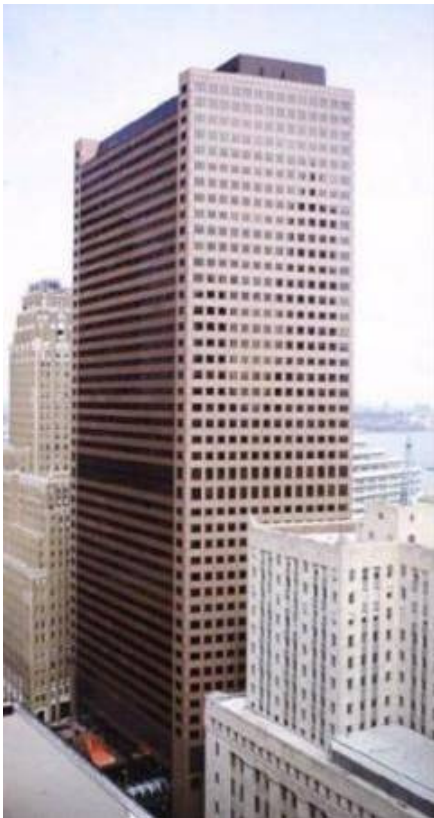
**WTC 7: 47 - Story, steel-frame building..**

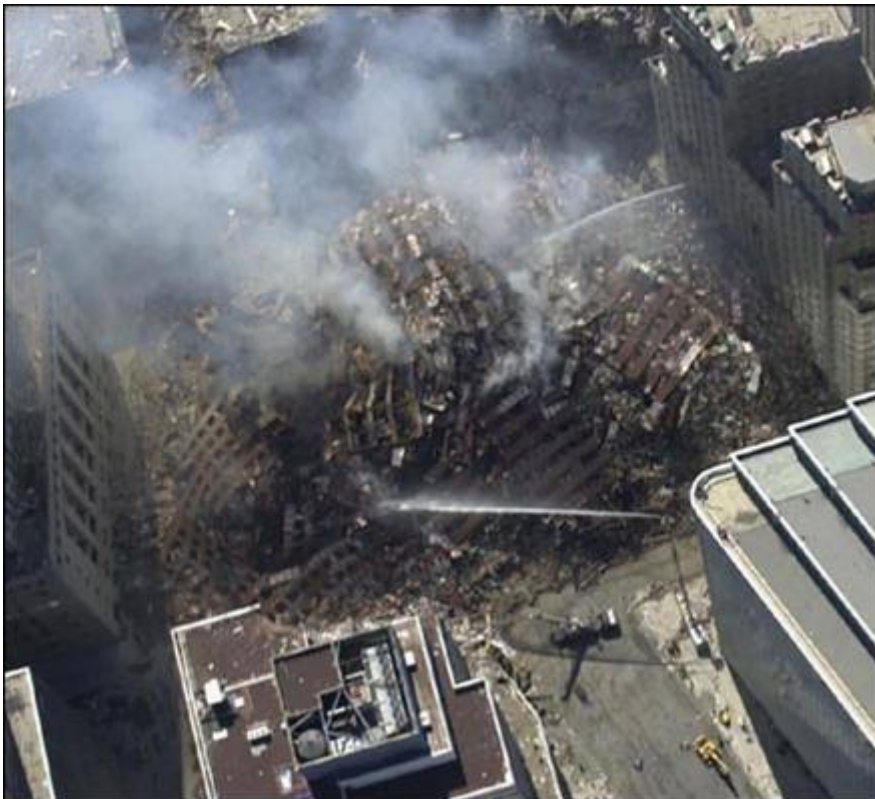
**WTC 7 collapsed completely on 9/11/2001, primarily onto its own footprint.**

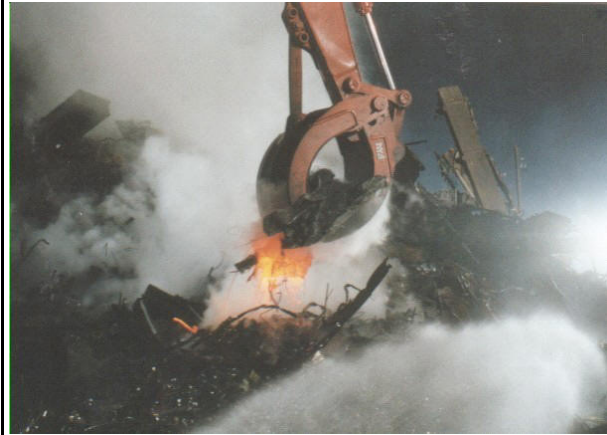
We see from the photograph above that solid metal from the WTC rubble existed at salmon-to-yellow-hot temperature (approx. 1550 - 1900 °F, 845 - 1040 °C.) The temperature is well above the melting temperatures of lead, zinc and aluminum, and these metals can evidently be ruled out since they would be runny liquids at much lower (cherry-red or below) temperatures. However, the observed hot specimen could be structural steel (from the building) or iron (from a thermite reaction) or a combination of the two. Additional photographs of the hot metal could provide further information and advance the research.

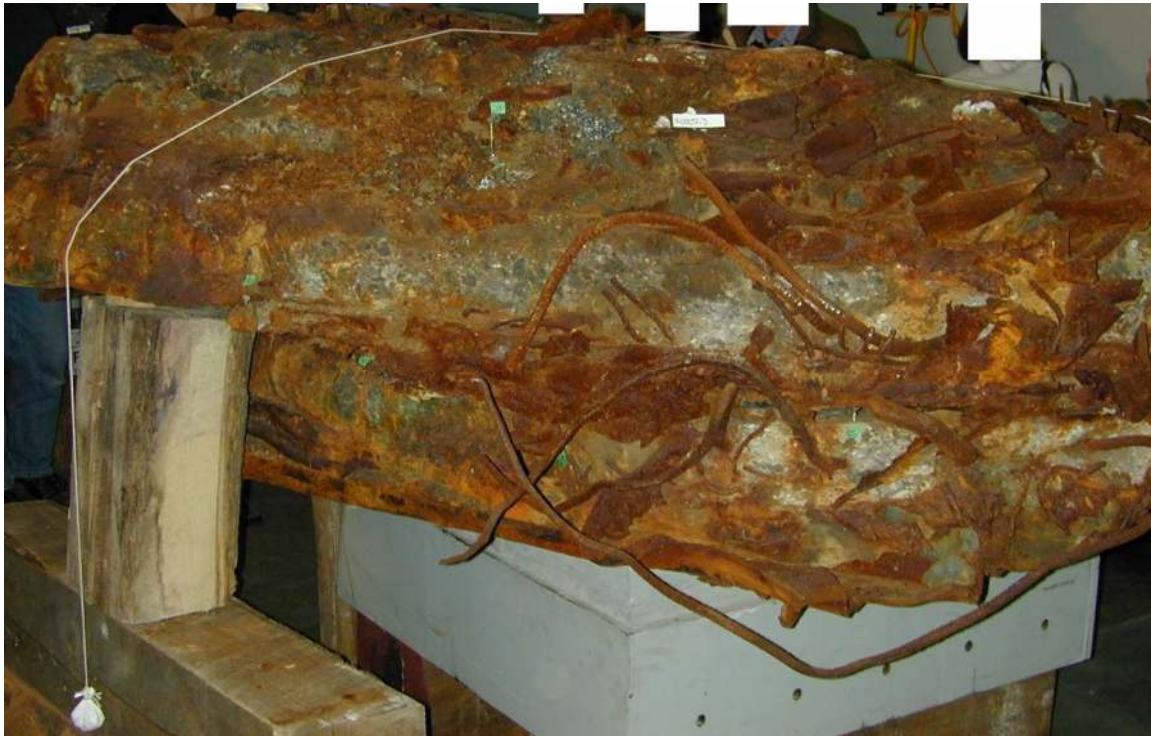
The following photograph has become available, evidently showing the now-solidified metal with entrained material, stored (as of November 2005) in a warehouse in New York:

The abundance of iron (as opposed to aluminum) in this material is indicated by the reddish rust observed. When a sample is obtained, a range of characterization techniques will quickly give us information we seek. X-ray energy dispersive spectrometry (XEDS) will yield the elemental composition, and electron energy-loss spectroscopy will tell us the elements found in very small amounts that were undetectable with XEDS. Electron-backscattered diffraction in the scanning electron microscope will give us phase information; the formation of certain precipitates can tell us a minimum temperature the melt must have reached. We will endeavor to obtain and publish these data, whatever they reveal.

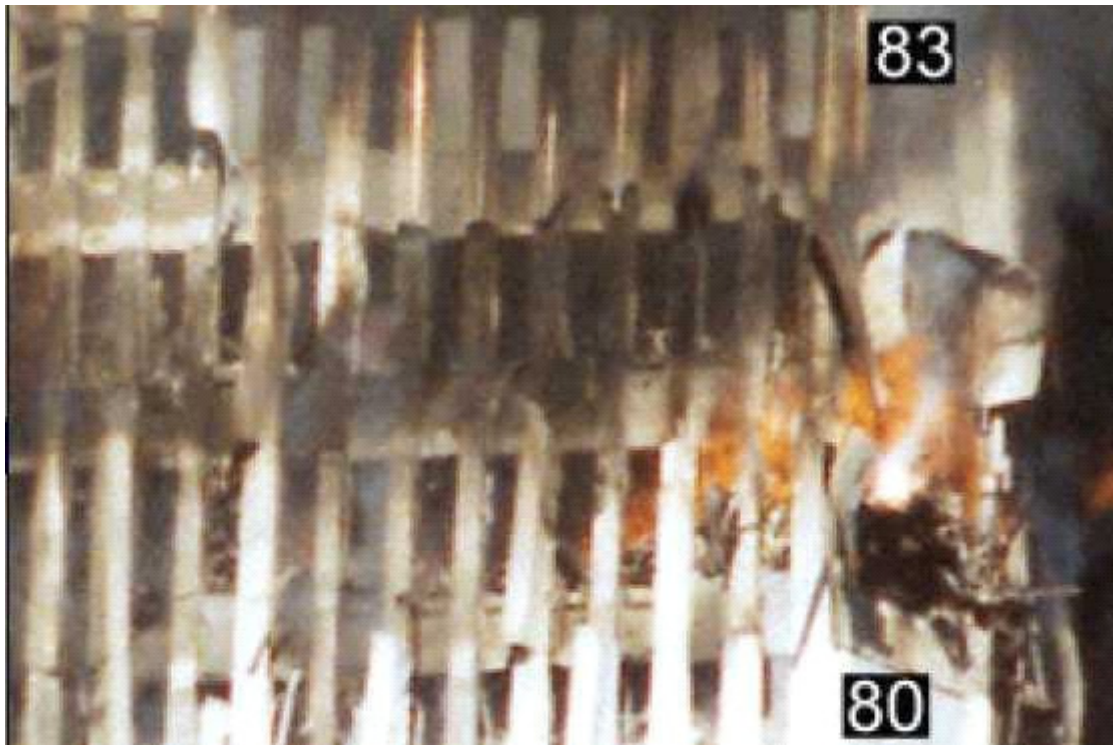
An intriguing photograph found as Figure 9-44 in the NIST report provides evidence for a highly exothermic reaction at the corner of the South Tower just minutes before its collapse. Furthermore, failure occurs at this very corner of the Tower as seen in this video footage:

“An **unusual flame** is visible within this fire. In the upper photograph {Fig 9-44} a **very bright flame**, as opposed to the typical yellow or orange surrounding flames, which is **generating a plume of white smoke**, stands out.” Source: NCSTAR 1-5A Chapter 9 Appendix C NIST Fig. 9-44. p. 344

“NIST reported (NCSTAR 1-5A) that just before 9:52 a.m., a **bright spot appeared** at the top of a window on the 80th floor of WTC 2, four windows removed from the east edge on the north face, **followed by the flow of a glowing liquid**. This flow lasted approximately four seconds before subsiding. **Many such liquid flows were observed from near this location in the seven minutes leading up to the collapse of this tower.**” Source:

Thus it is established that the "glowing liquid" flow is associated spatially and temporally with the "bright spot" observed on the corner of the 80th floor of WTC 2. The photograph below shows, for comparison, a thermite reaction with a white aluminum-oxide dust plume extending from very bright reaction region. (Experiment by the author and colleagues in which thermite-plus-sulfur cut through a steel cup in a fraction of a second. Any thermite reaction is a dangerous reaction and should only be performed by a trained professional capable of assessing the hazards and risks.) The similarities between the known thermite reaction and the hitherto unknown reaction at the WTC Tower are plain to see. These discoveries strongly motivate an immediate in-depth investigation of the use of thermite-type reactions in the destruction of the World Trade Center on 9/11/2001.

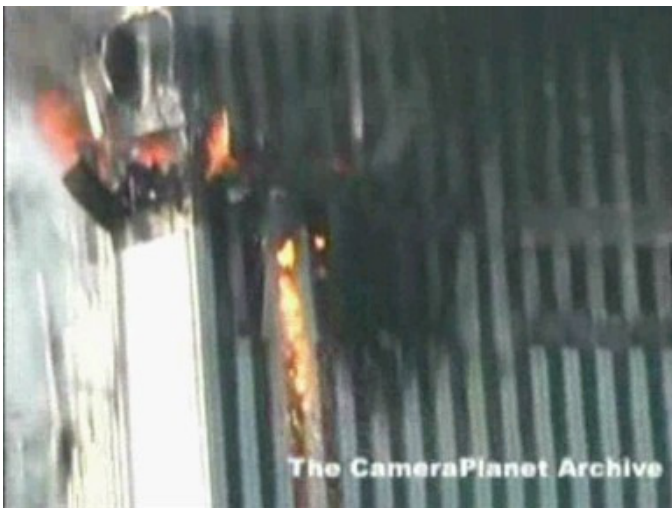
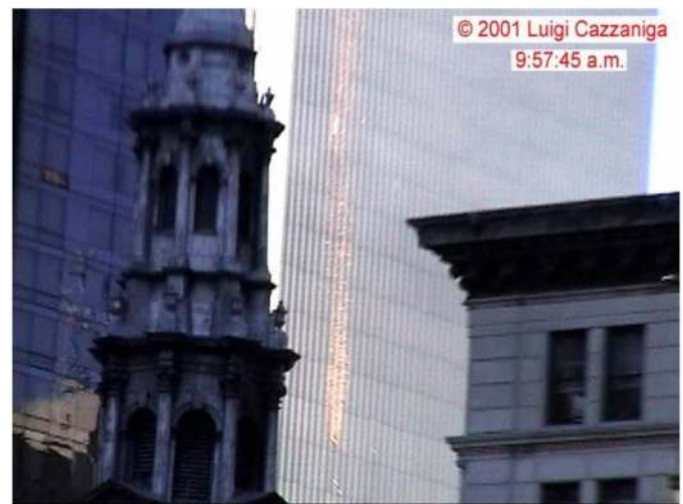
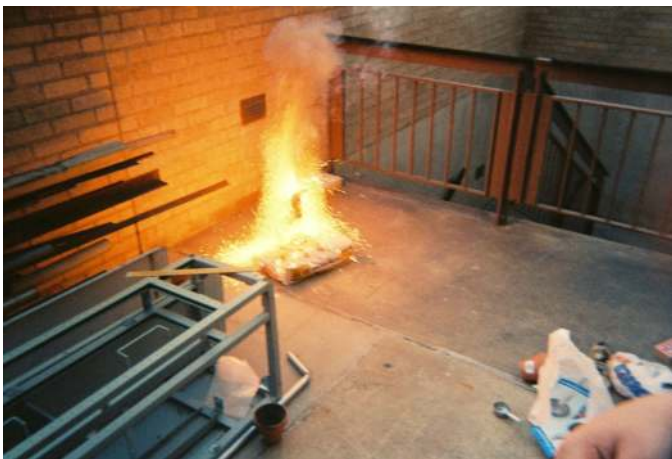
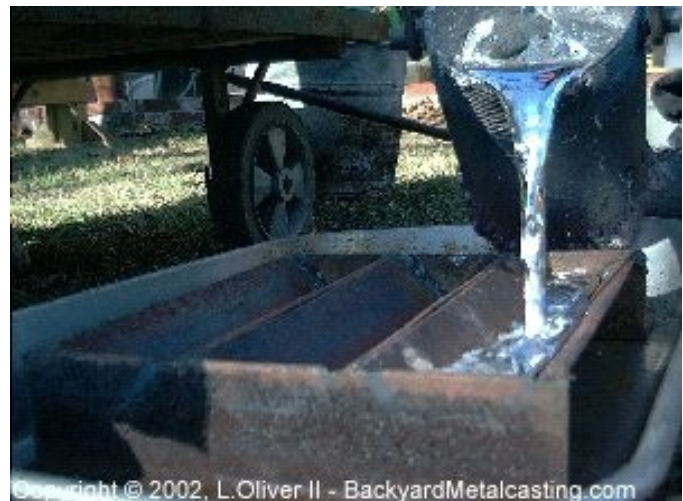
Is the falling molten metal from WTC Tower 2 (Top photos) more likely molten iron from a thermite reaction (lower left) OR pouring molten aluminum (lower right)?

Who can deny that liquid, molten metal existed at the WTC disaster? The yellow color implies a molten-metal temperature of approximately 1000 °C, evidently above that which the dark-smoke hydrocarbon fires in the Towers could produce. If aluminum (e.g., from the plane) had melted, it would melt and flow away from the heat source at its melting point of about 650 °C and thus would not reach the yellow color observed for this molten metal. Thus, molten aluminum is already ruled out with high probability. But molten iron with the characteristics seen in this video is in fact consistent with a thermite-reaction attacking the steel columns in the Tower, thus weakening the building just prior to its collapse, since thermite produces molten iron at yellow-to-white hot temperatures. (As some of the molten metal hits the side of the building in the video clip above, the white-hot interior is evidently exposed as the metal "splashes".) Also, the fact that the liquid metal retains an orange hue as it nears the ground (right photograph) further rules out aluminum, and suggests a mid-flight thermite reaction (typical of thermite). Here are two independent videos of the yellow-white liquid metal pouring out of the South Tower: <http://video.google.com/videoplay?docid=->

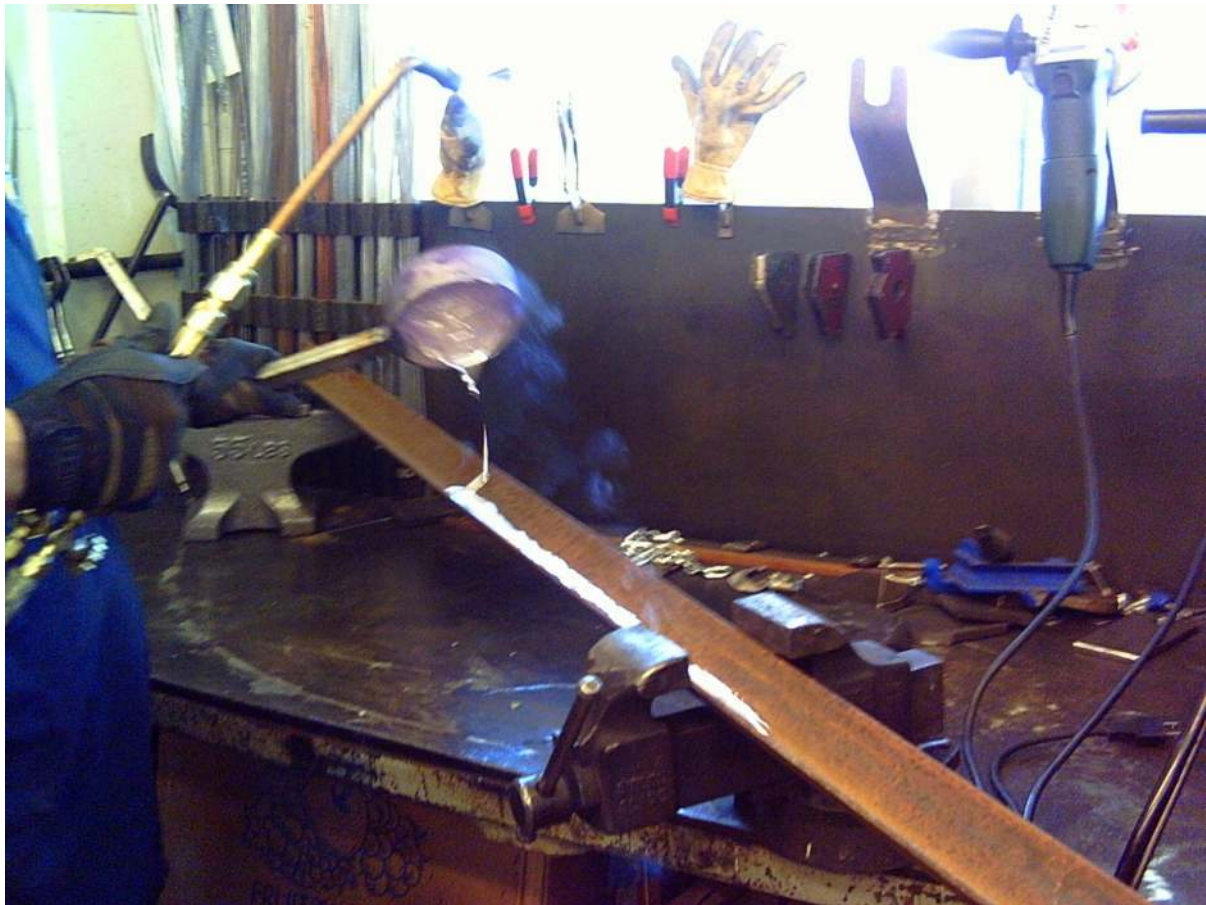
Molten aluminum poured onto rusted steel: silvery flow, and **no** violent reactions observed at all (contrary to predictions by some of a vigorous aluminum-rust “thermitic reaction”). Same result -- when the rusty steel piece was pre-heated with the torch.

We also noted that while a steel pan holding the aluminum glowed red and then yellow hot, when poured out the falling aluminum displayed a silvery-gray color, adding significantly to the evidence that the yellow-white molten metal flowing out from the South Tower shortly before its collapse was NOT molten aluminum. (Recall also that the yellow color of the molten metal (video clip above) implies a temperature of approximately 1100°C -- too high for the dark-smoke hydrocarbon fires burning in the building.) This is a point worth emphasizing: aluminum has low emissivity and high reflectivity, so that in daylight conditions after falling through air 1-2 meters, molten aluminum will appear silvery-gray, while molten iron (with its characteristic high emissivity) will appear yellow-white (at ~1100°C) as observed in the molten metal dripping from the South Tower just before its collapse (see: <http://www.supportthetruth.com/jones.php> ). We also recall that this molten metal, after falling approximately 150 meters (or yards) still retained a reddish orange color (photograph above). This is not the behavior of falling, molten aluminum.

NIST states the hypothesis that flowing aluminum with partially burned organic materials mixed in, "can display an orange glow." But will it really do this? I decided to do an experiment to find out. Our group melted aluminum in a steel pan using an oxy-acetylene torch. Then we added plastic shavings -- which immediately burned with a dark smoke, as the plastic floated on top of the hot molten aluminum. Next, we added wood chips (pine, oak and compressed fiber board chips) to the liquid aluminum. Again, we had fire and smoke, and again, the **hydrocarbons floated on top** as they burned. We poured out the aluminum and all three of us observed that it appeared silvery, not orange! We took photos and videos, so we will have the recorded evidence as these are processed. Of course, we saw a few burning embers, but this did not alter the silvery appearance of the flowing, falling aluminum.

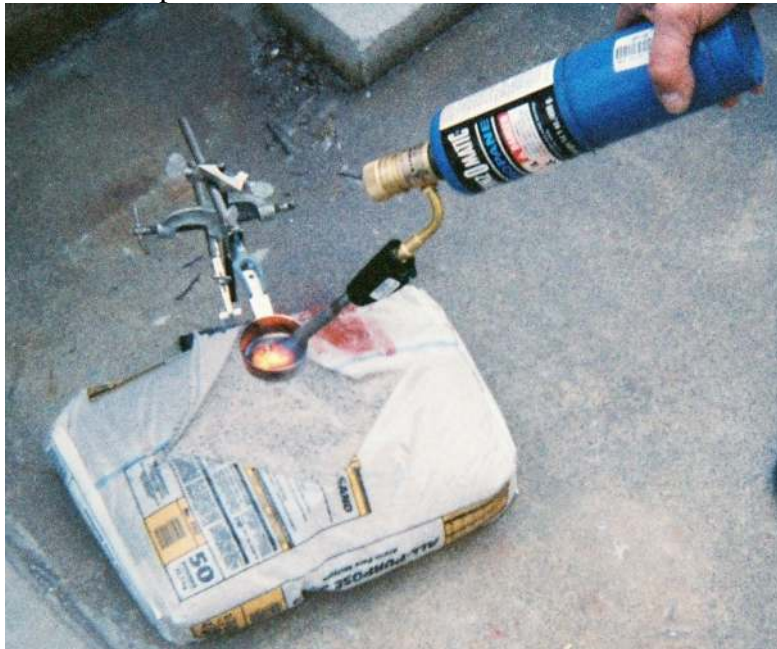
Thermite did not ignite when heated with a propane torch.

It is important to note that initiating the thermite reaction requires temperatures well above those achieved by burning jet fuel or office materials -- which is an advantage of using thermite charges over conventional monomolecular explosives such as TNT, RDX and PETN. Below is a photograph of an experiment performed by the author and colleagues at BYU in which a sample of thermite was heated to orange-hot temperature (about 1700 °F). We demonstrated that the thermite reaction would not ignite at this high temperature. Later, the thermite reaction was triggered by burning a magnesium strip in contact with the thermite. An electrical superthermite "match" could have been used and remotely triggered via radio signal.

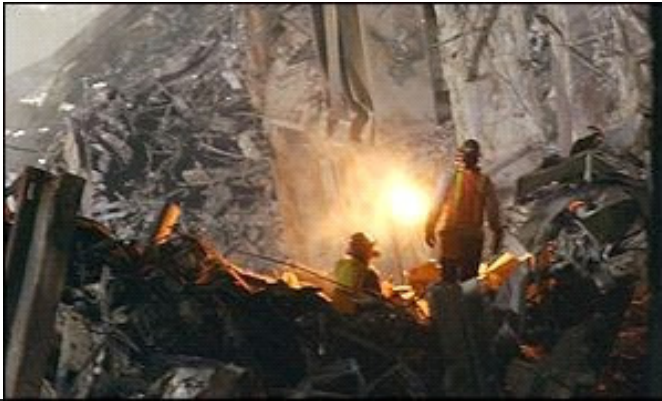
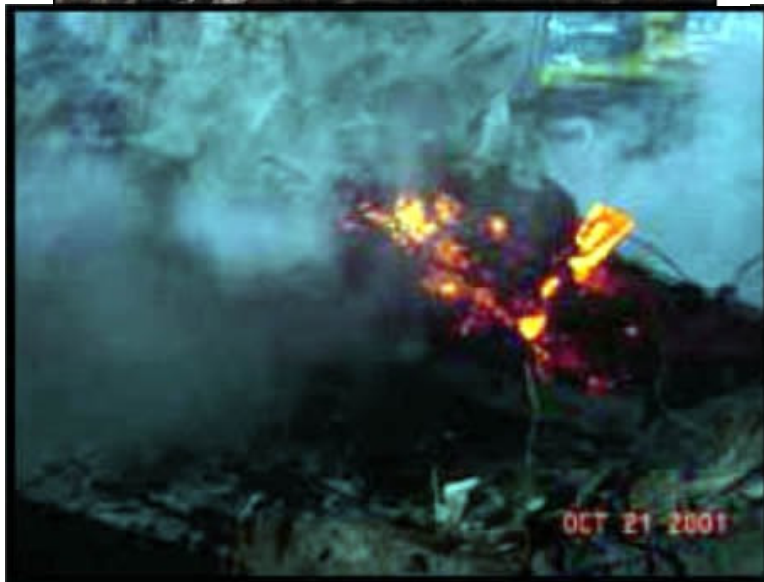
The top photo (<http://news.bbc.co.uk/2/hi/science/nature/1858491.stm>) may show the glow of hot metal in the rubble; the second photo clearly does so. It is labeled "Red Hot Debris" and is published in **LiRo News, Nov. 2001**, <http://www.liro.com/lironews.pdf>. Moreover, there is recorded eyewitness testimony of the molten metal pools under both Towers and WTC 7; see: <http://georgewashington.blogspot.com/2005/12/why-was-there-molten-metal-under.html>. Video clips provide eye-witness evidence regarding this metal at ground zero: [http://plaguepuppy.net/public\\_html/video%20archive/red\\_hot\\_ground\\_zero\\_low\\_quality.wmv](http://plaguepuppy.net/public_html/video%20archive/red_hot_ground_zero_low_quality.wmv), <http://video.google.com/videoplay?docid=-3060923273573302287>.

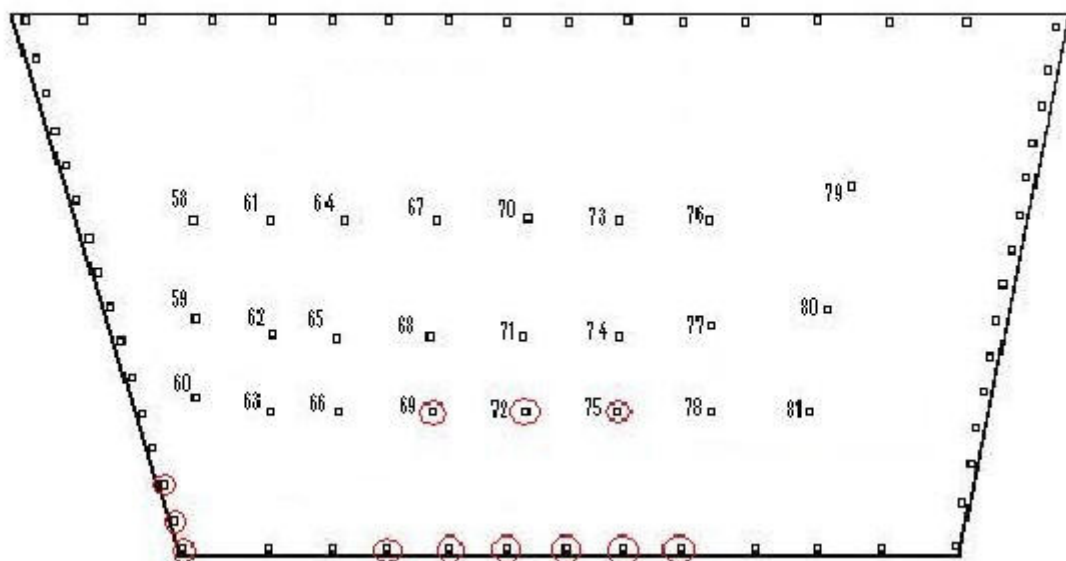
Diagram showing steel-column arrangement in WTC 7, view looking down on the roof. Circled columns were possibly damaged due to debris from WTC 1 collapse, some 350 feet away (NIST, 2005) so the damage was clearly non-symmetrical, and evidently, none of the core columns was severed by falling debris. WTC 7 was never hit by a plane.

As you observed (link above), WTC 7 collapsed rapidly and nearly-straight-down symmetrically -- even though fires were randomly scattered in the building. WTC 7 fell about seven hours after the Towers collapsed, even though no major persistent fires were visible (considerable dark smoke was seen). There were twenty-four huge steel support columns inside WTC 7 as well as huge trusses, arranged non-symmetrically, along with some fifty-seven perimeter columns, as indicated in the diagram below (FEMA, 2002, chapter 5; NIST, 2005).

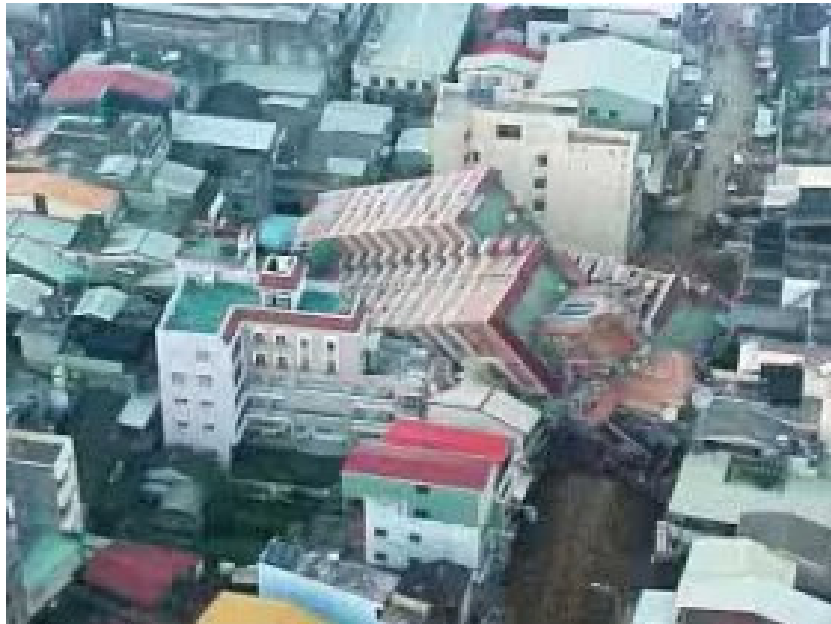
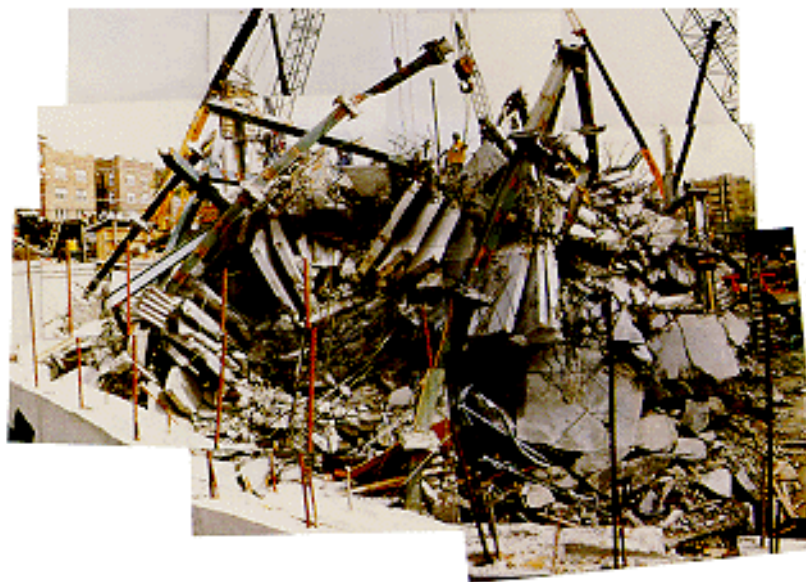
Non-symmetrical collapse of tall buildings when due to random causes. L'Ambiance Plaza collapse (right) shows how pancaked concrete floor slabs are largely intact and clearly reveal stacking effects with minimal fine dust, as expected from random progressive collapse. By contrast, concrete floors in the Twin Towers and WTC 7 were pulverized to dust -- as is common in controlled demolitions using explosives.

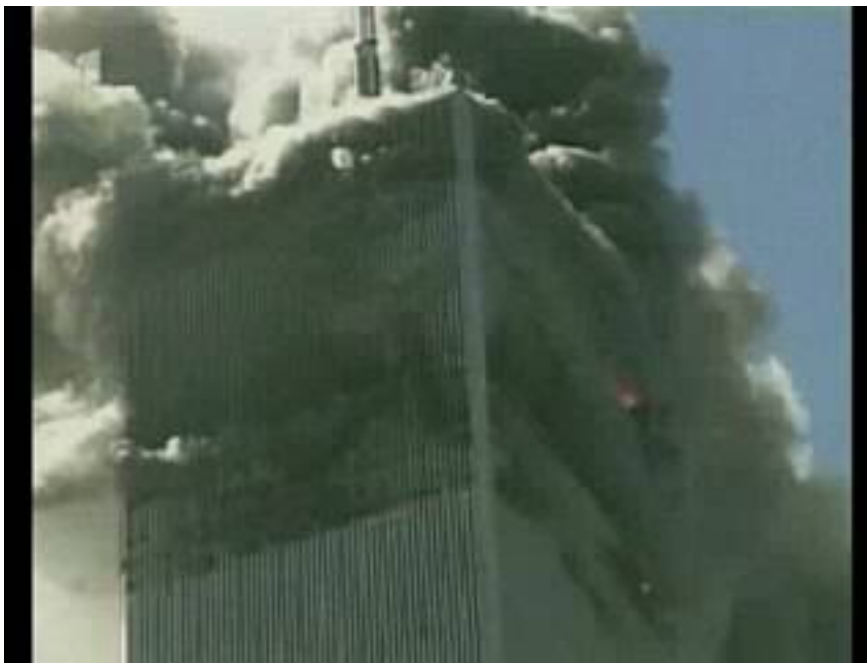
North Tower showing antenna (top) at beginning of collapse.

Review of videotape recordings of the collapse taken from various angles indicates that the transmission tower on top of the structure began to move downward and laterally slightly before movement was evident at the exterior wall. This suggests that **collapse began with one or more failures in the central core area of the building.** (FEMA, 2002, chapter 2; emphasis added.)

Yes, we can see for ourselves that the antenna drops first from videos of the North Tower collapse. (See [http://911research.wtc7.net/wtc/evidence/videos/wtc1\\_close\\_frames.html](http://911research.wtc7.net/wtc/evidence/videos/wtc1_close_frames.html); also <http://home.comcast.net/~skydrifter/collapse.htm>.) A NY Times article also notes this behavior:

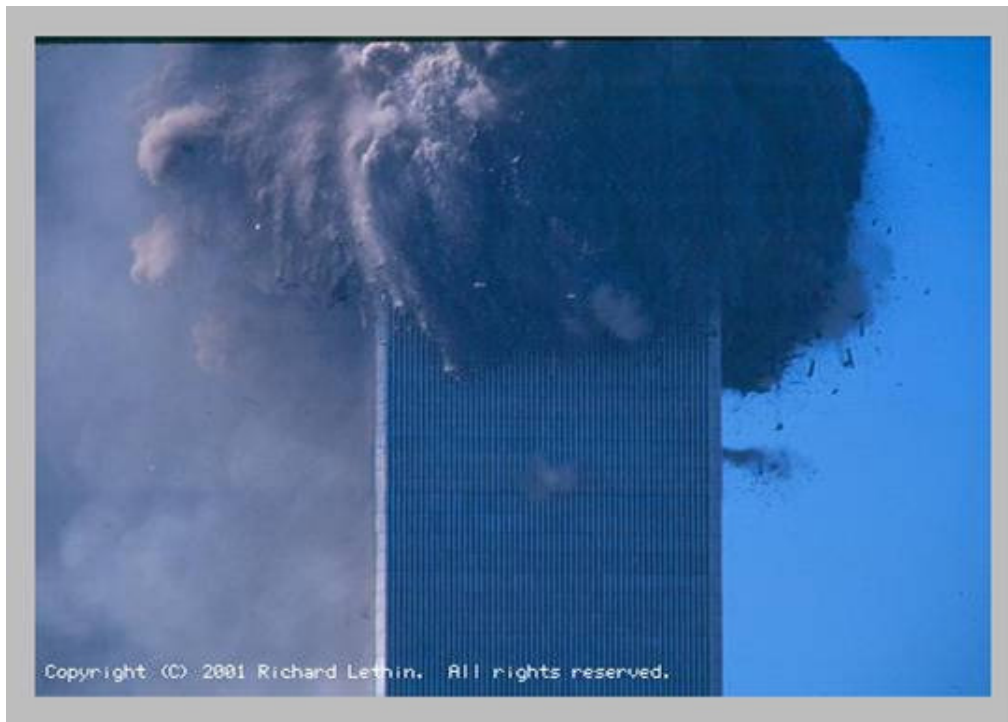
North Tower during top-down collapse.  
Notice mysterious horizontal plumes far below pulverization region.

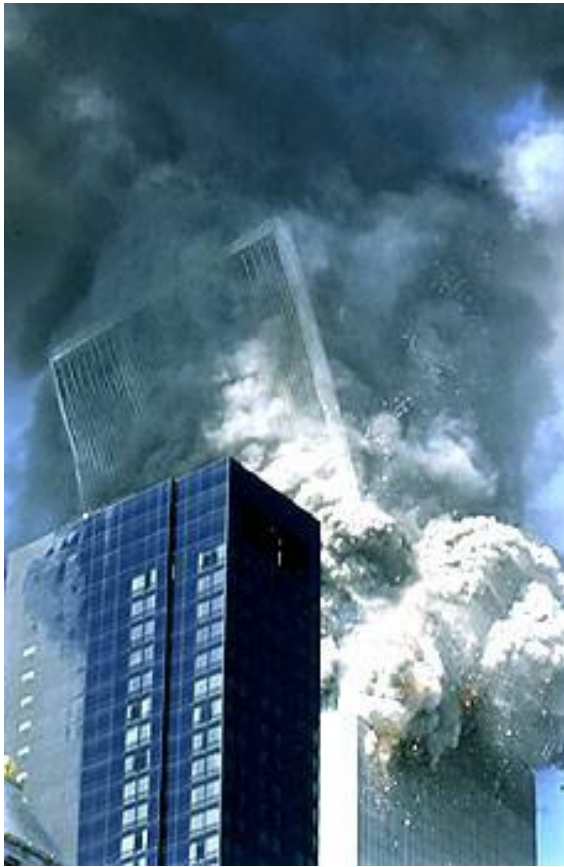
Top ~ 30 floors of South Tower topple over.  
What happens to the block and its angular momentum?

We observe that approximately 30 upper floors begin to rotate as a block, to the south and east. They begin to topple over, not fall straight down. The torque due to gravity on this block is enormous, as is its angular momentum. But then – and this I’m still puzzling over – this block turned mostly to powder *in mid-air*! How can we understand this strange behavior, without explosives? Remarkable, amazing – and demanding scrutiny since the US government-funded reports failed to analyze this phenomenon. But, of course, the Final NIST 9-11 report “**does not actually include the structural behavior of the tower after the conditions for collapse initiation were reached.**” (NIST, 2005, p. 80, fn. 12; emphasis added.)

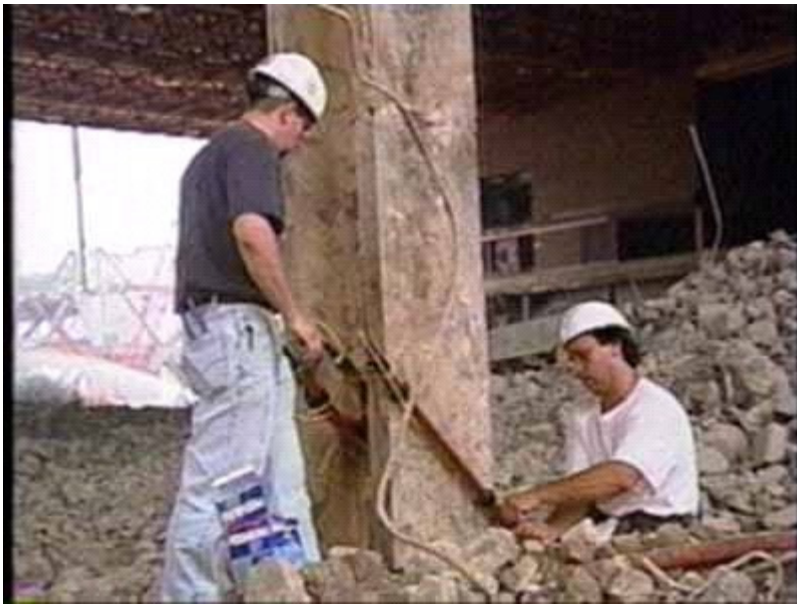
Above: two men install a conventional cutter charge to steel column, preparing for a controlled demolition of the building. Notice the narrow width/size of the explosive cutter charge. From History Channel: “Wrecking ball – Modern marvels” and thanks to Robert Moore and <http://piratenews.org/911con.html> . For comparison, observe some of the angle-cut columns seen at Ground Zero after 9/11/2001, below. (Notice especially the uneven cut at the back of the column and the clinging previously-molten metal on both the outside AND the inside of the column, left photo, suggesting this was NOT cut using an oxy-acetylene torch, but rather that a highly exothermic chemical reaction was involved in cutting through this steel column.)

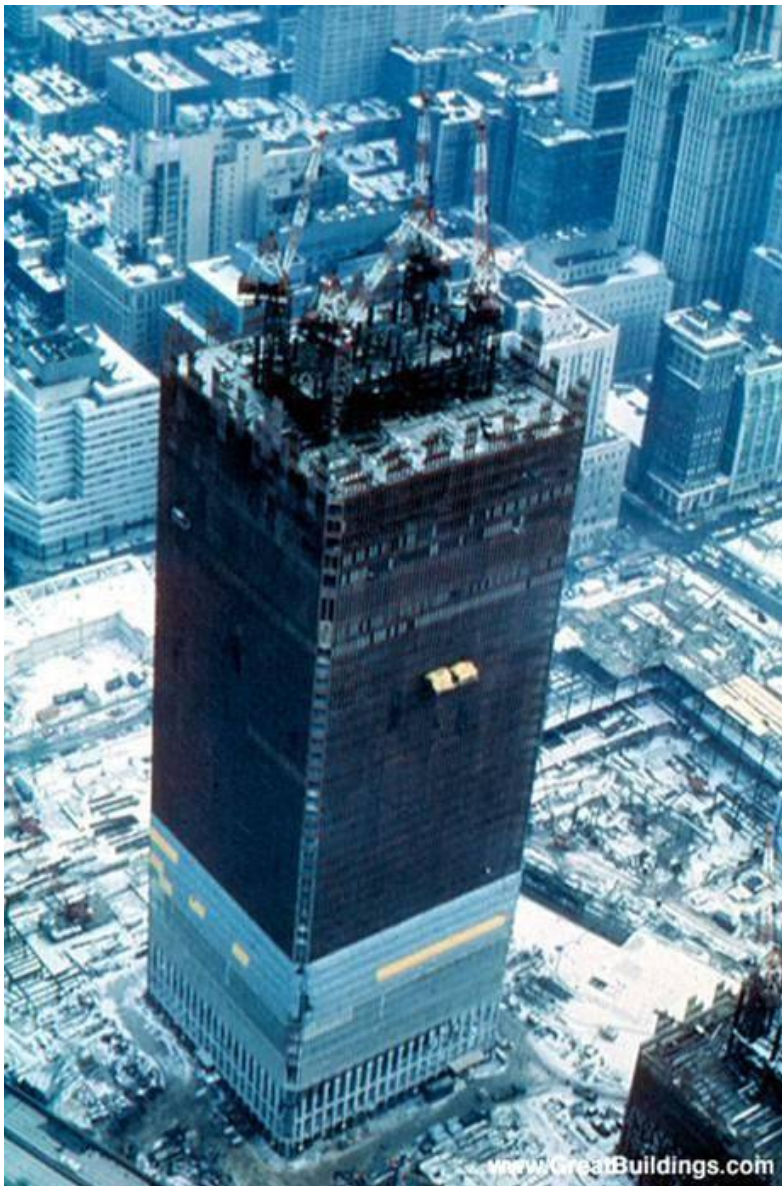
The WTC towers were solidly constructed with 47 steel core columns and 240 perimeter steel columns. 287 steel-columns total.

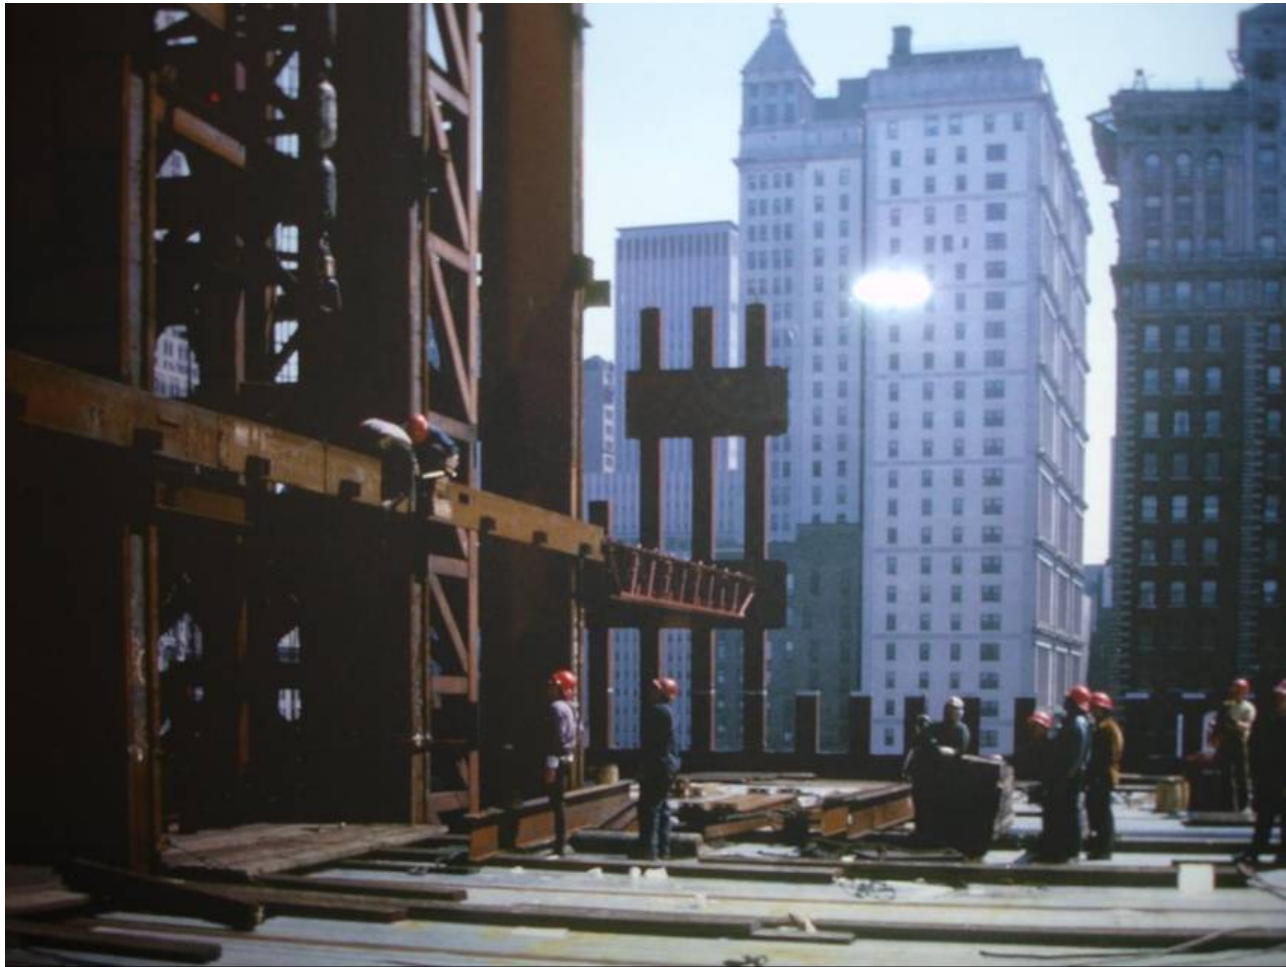
Steel-frame: Huge core (left) is an enormous heat sink. Notice workers standing on floor pan which is firmly attached to the interconnected core columns. Clearly, **the Towers were not “hollow tubes.”**
